# THE MANNERHEIM LINE 1920–39

Finnish Fortifications of the Winter War

**BAIR IRINCHEEV**

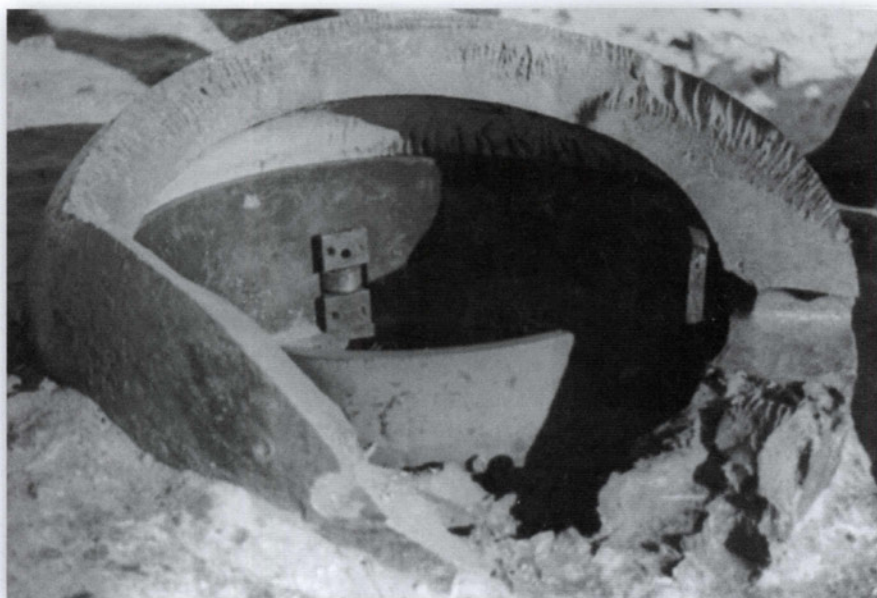
The armoured tower of a Finnish bunker destroyed by a direct hit from a heavy Soviet shell. (Carl-Fredrik Geust)

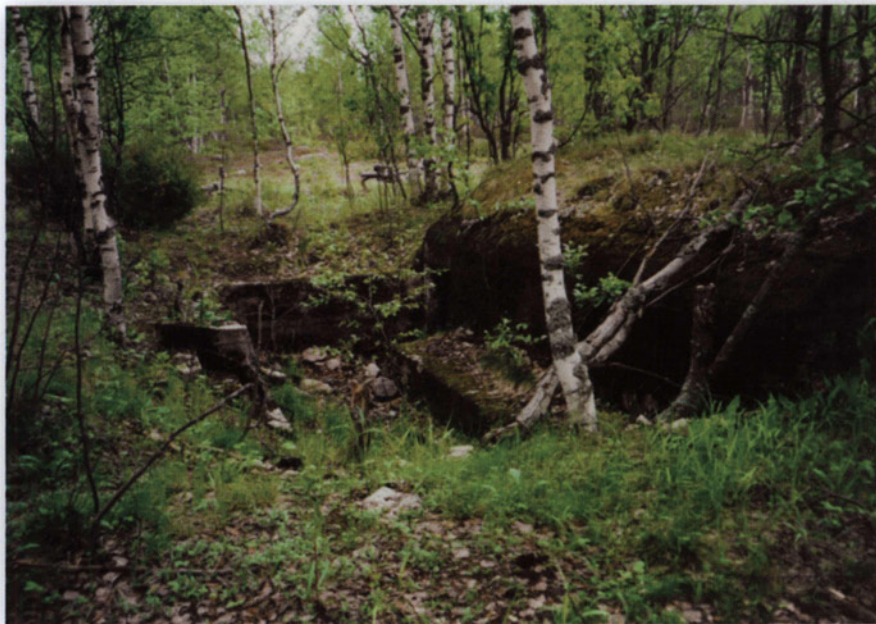
A so-called 'concrete trench', a cheap concrete bunker from the 1920s, which provided shelter for 5–10 men and a firing step. Two such bunkers were built in the Lähde sector, and were not destroyed by Red Army sappers after the war. (Bair Irincheev)

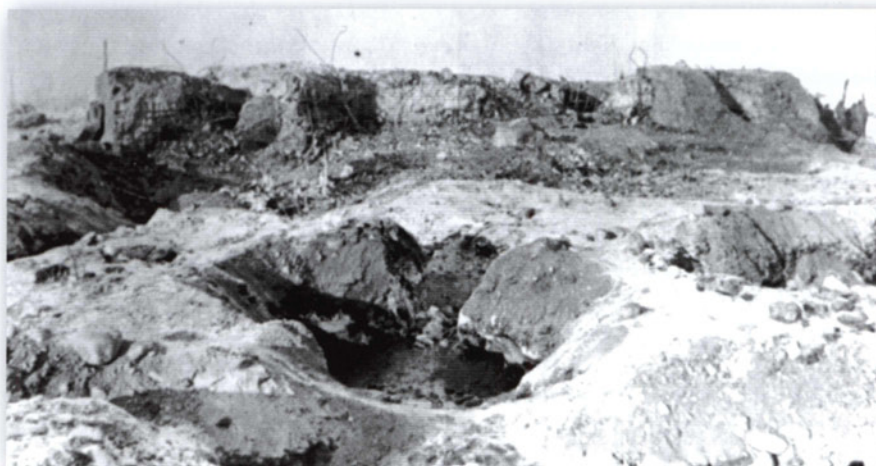
The ruins of the Test bunker. Although the bunker had no military significance during the Winter War, its size and formidable appearance drew heavy Soviet artillery fire during the battles in the Lähde sector. (Carl-Fredrik Geust)

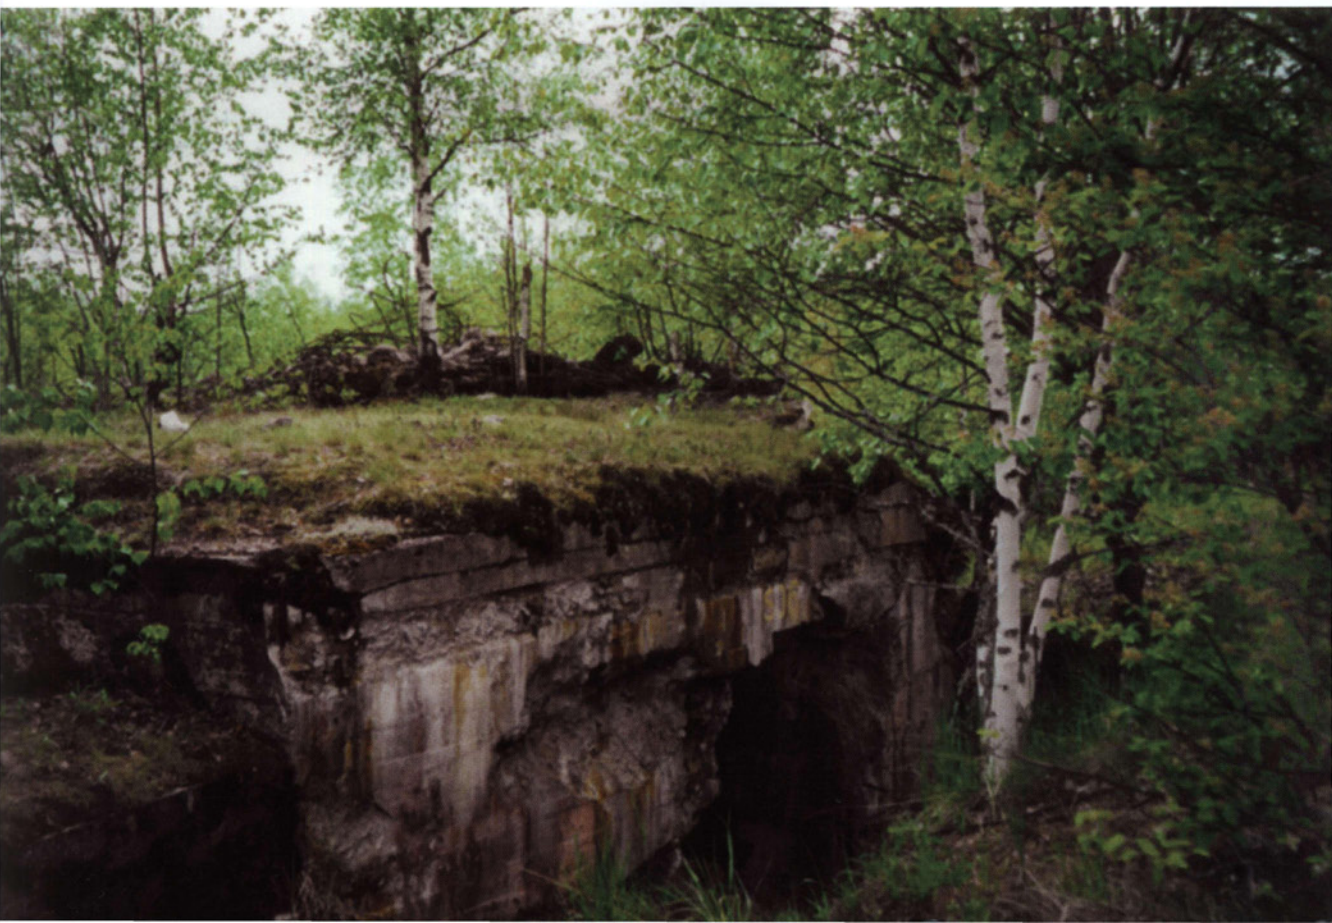
The remains of the Sjö 'Torsu' command bunker in the Lähde sector. On 13 February 1940 over 20 Finnish wounded soldiers surrendered to the Red Army, after Soviet sappers threatened to blow up the bunker with all men inside. (Bair Irincheev)

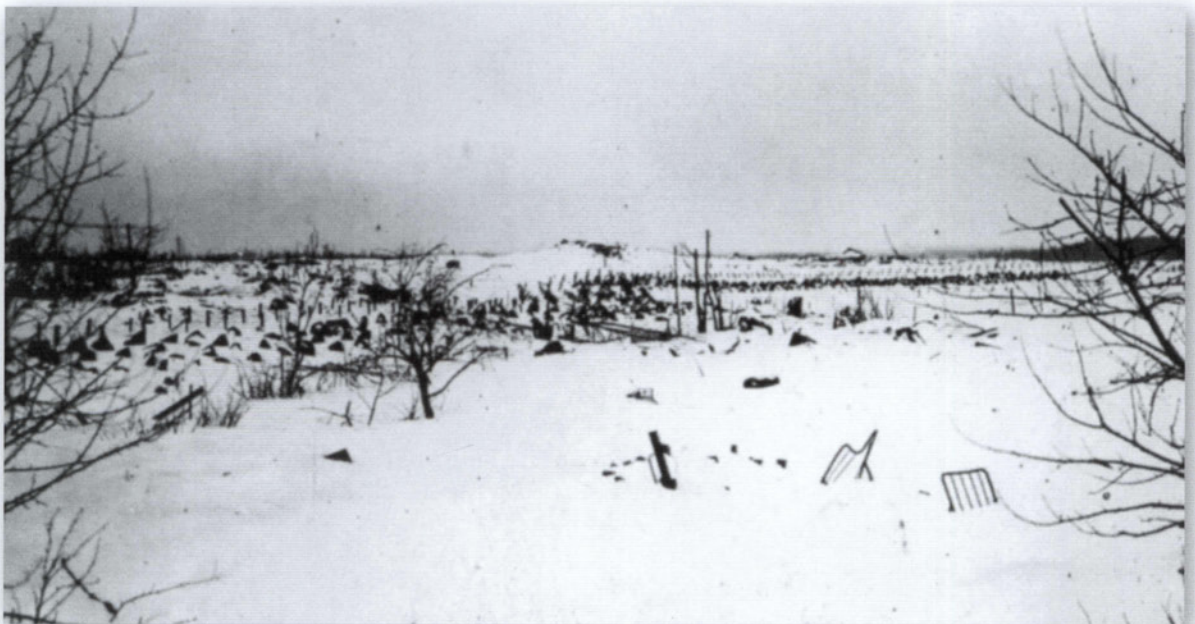
A view of the second bunker line in the Muolaa sector. The two bunkers dated from the 1920s, and the anti-tank and barbed-wire obstacles are clearly visible. (Colonel Skvortsov Collection)

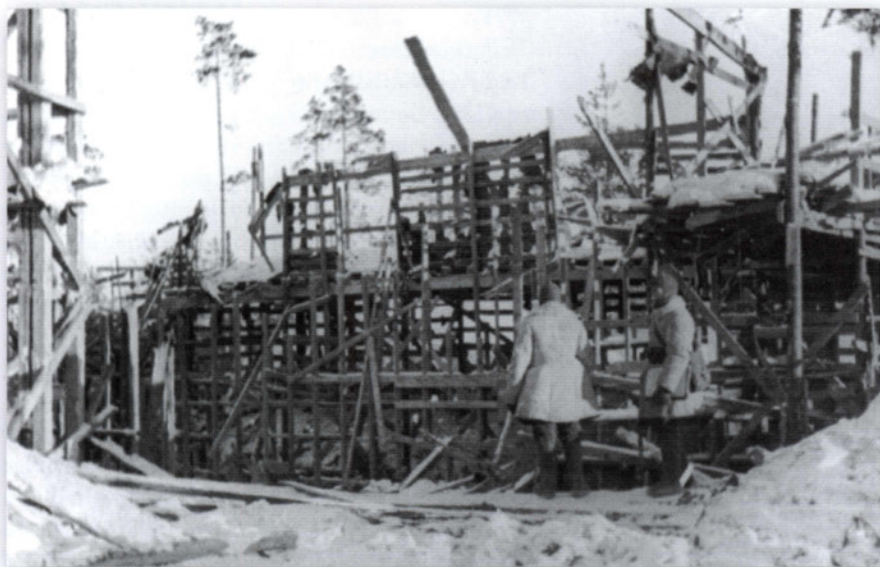
Bunker No. 18 in the Summa Village sector, following its capture by the Red Army. The defences were unfinished when hostilities between the USSR and Finland broke out. Some Finnish officers claimed the armoured towers were shot off the bunkers with ease because the concrete had not hardened sufficiently when the bombardments began. (Carl-Fredrik Geust)

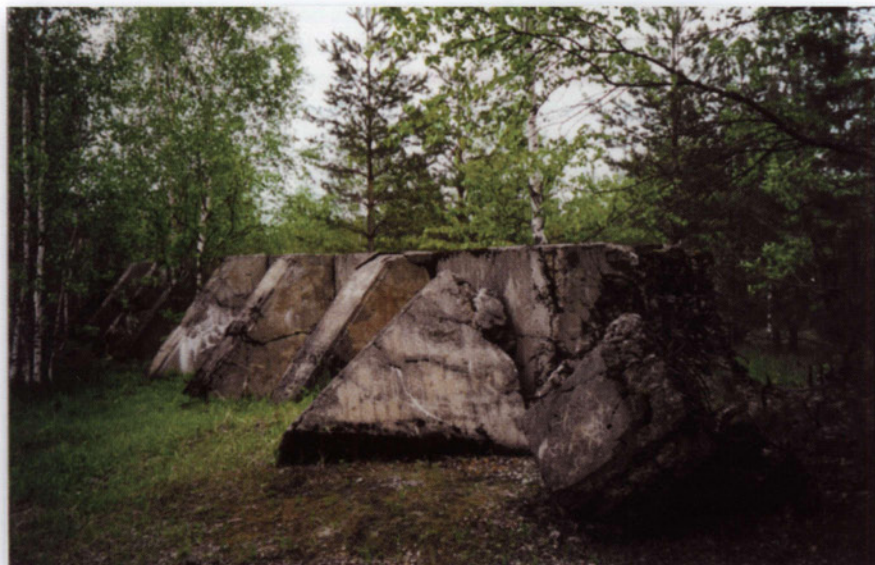
A view of the formidable Test bunker today. The break in the wall was most likely the result of destruction of the bunker by Red Army sappers during the assault on 11–12 February 1940. (Bair Irincheev)
